Subj: COMMAND INVESTIGATION INTO THE FACTS AND CIRCUMSTANCES
SURROUNDING THE FIRE ONBOARD USS BONHOMME RICHARD (LHD 6) ON
OR ABOUT 12 JULY 2020

**INTO THE FIRE ABOARD
USS BONHOMME RICHARD (LHD-6)
12 JULY 2020**

5830
Memo N00/156
5 Apr 21

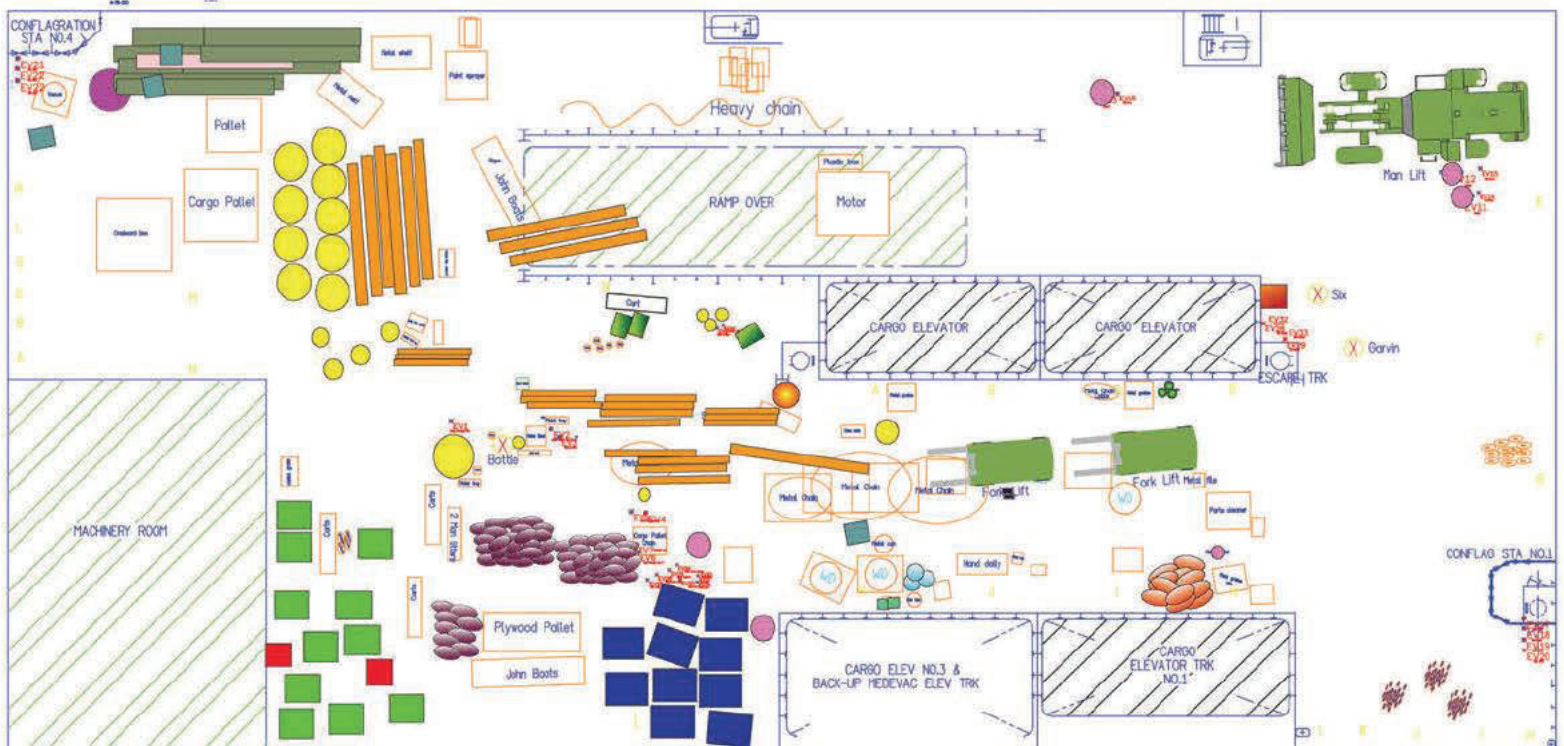
3. ATF determined that once the fire ignited, it spread to the significant amount of combustible material stored within Lower V (See Figure 1), which included dozens of tri-walls filled with gear and equipment and three fueled vehicles (a forklift, a man-lift, and a cargo tractor). [Encl 5]

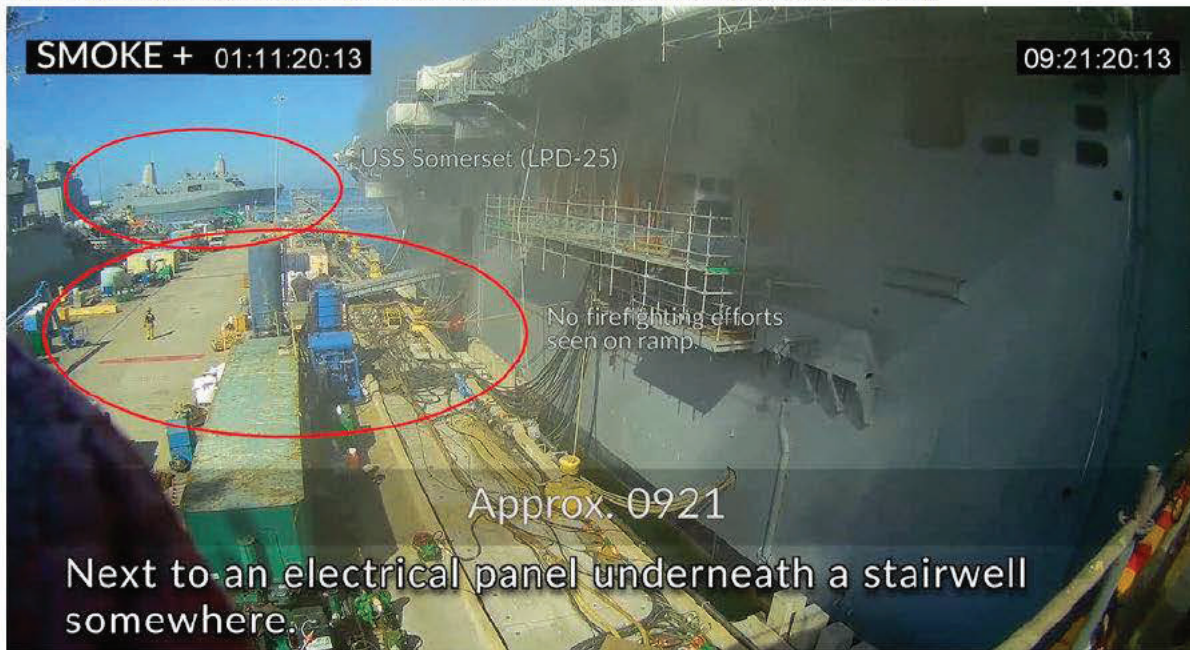
Figure 8 is a screen capture from SDFD (b) (6)'s helmet-mounted camera footage (subtitles and other text added by the investigation team). SDFD (b) (6) was speaking about the location of the fire. No personnel are visible by the sideport door.

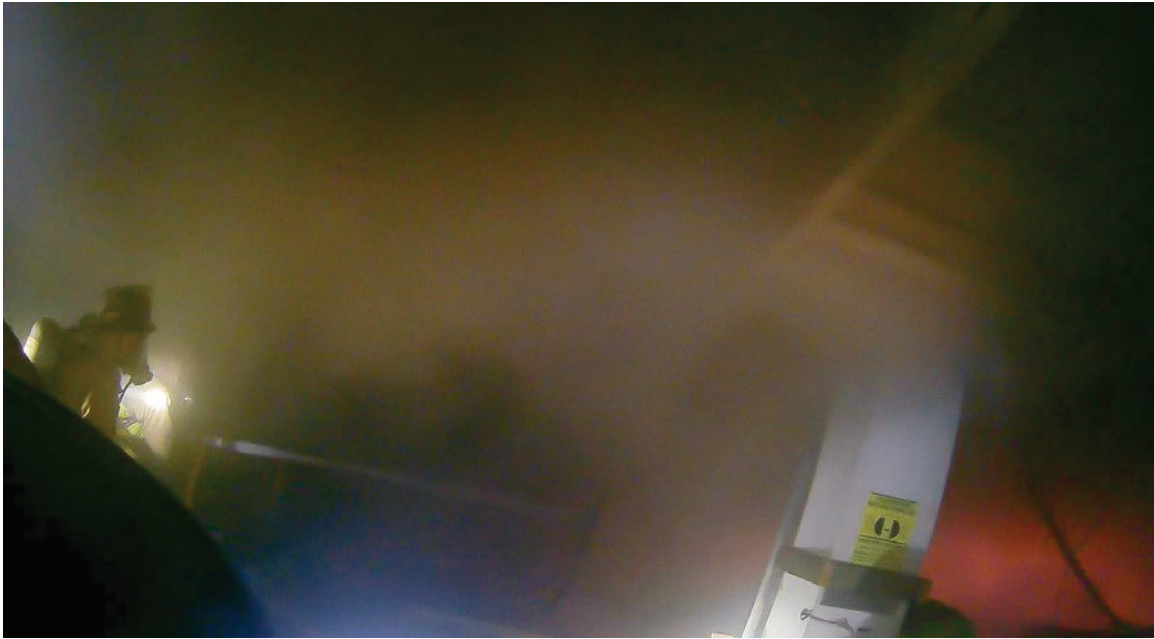
Figure 11 shows a screen capture from SDFD Firefighter (b) (6)'s helmet-mounted camera footage. This image captures the first time agent was applied to fire on 12 July 2020, as SDFD teams applied firefighting water to the radiant fire in Upper V at approximately 0951.

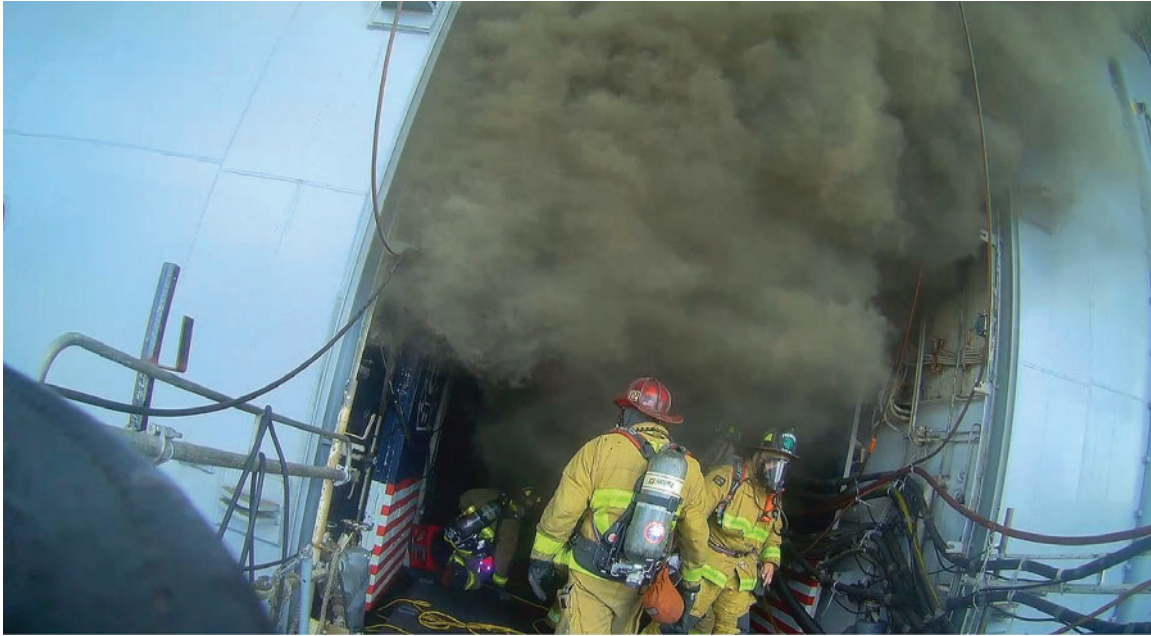
94. As the firefighting efforts continued, SDFD (b) (6) and SDFD (b) (6) observed smoke conditions were deteriorating. The fire transitioned to producing heavy black smoke with a yellow tinge, and multiple SDFD firefighters observed smoke being pulled back into the ship. At approximately 1035, SDFD (b) (6) informed the Assistant Operations Chief, NCFD (b) (6), that firefighters had "lost the space" (referring to Upper V). He then informed the firefighting teams, "This compartment is about to blast, get what you can, get what you can." NCFD (b) (6) radioed his concerns to SDFD (b) (6) and announced his intention to begin withdrawing the attack teams from the ship. Additionally, FEDFIRE (b) (6) received a report from FEDFIRE (b) (6) about the change in smoke conditions. FEDFIRE (b) (6) also noticed the smoke had become very heavy and black. Based on these reports, FEDFIRE (b) (6) also made the call to evacuate and pull all gear off the ship. At 1037, the ICP officially ordered all firefighting teams to evacuate BONHOMME RICHARD. [Encl 126, 141, 148, 164, 181, 229, 230, 239, 240, 241]

Figure 12 shows a screen capture from SDFD Firefighter (b) (6)'s helmet-mounted camera footage, illustrating smoke conditions at approximately 1035.

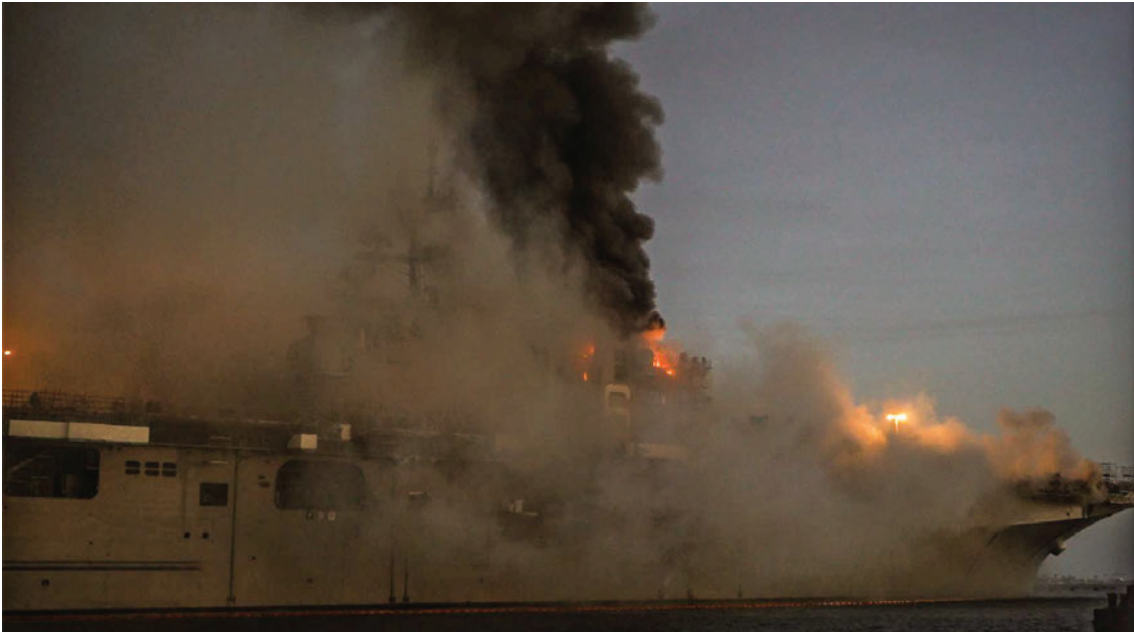
160. At 1954, the fire was observed to be venting out of the superstructure and continued to burn out of control, with an active fire visible from BONHOMME RICHARD's stacks. There were no FEDFIRE personnel or Sailors aboard BONHOMME RICHARD at this time. [Encl 249, 297, 377, 384]

Figure 15 shows BONHOMME RICHARD burning in the evening on 12 July 2020.

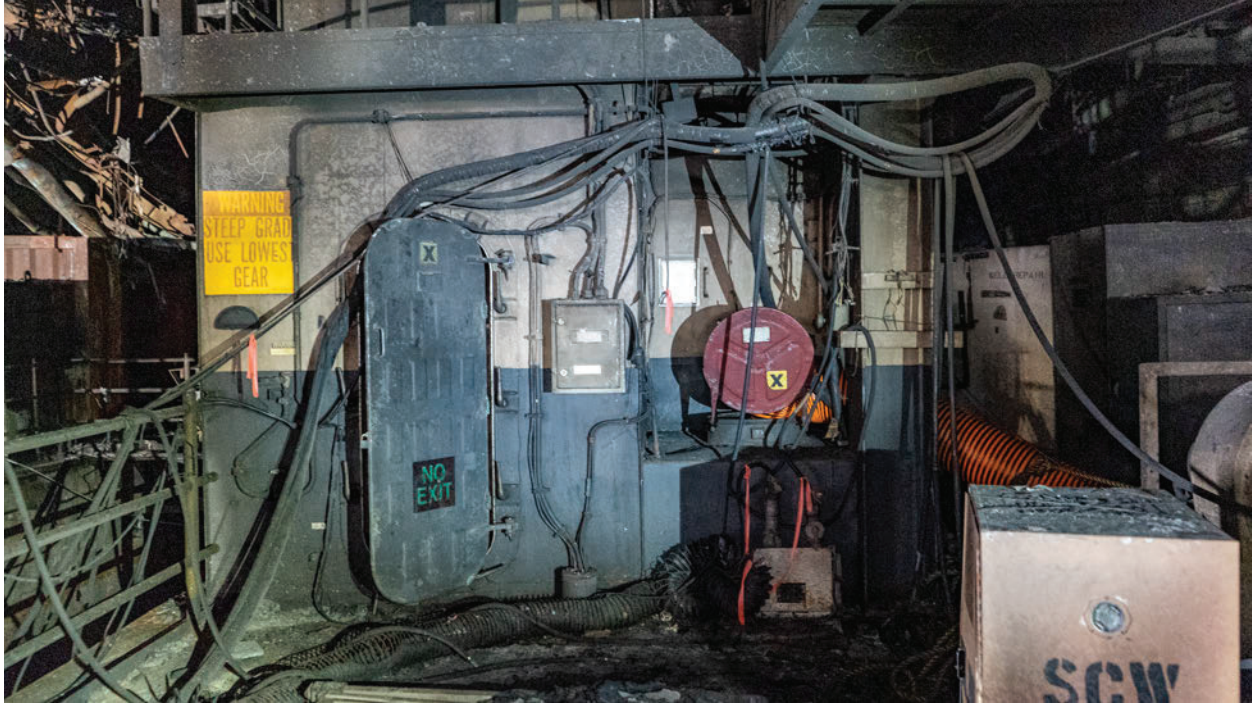
393. None of the 100 IET drills conducted from 23 July 2019 to 12 July 2020 employed AFFF. [Encl 44, 574]

Figure 29, Still photo of AFFF push-buttons for sprinkler groups 15 and 16 serving Lower V (16 on left; 15 on right). These push-buttons are in Upper V amidships. An open hatch obstructs visibility of the push-buttons.

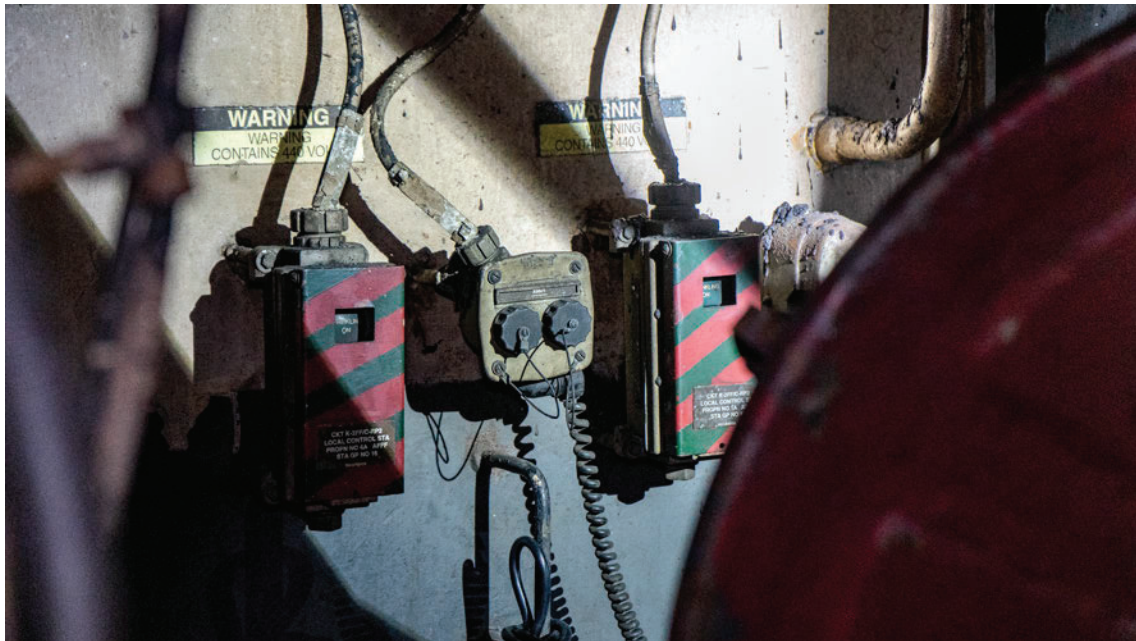
Figure 30, Still photo of AFFF push-buttons for sprinkler groups 15 and 16 serving Lower V with covers closed (16 on left; 15 on right). These push-buttons are in Upper V amidships. The photo shows proximity to open hatch, which obstructs visibility of the push

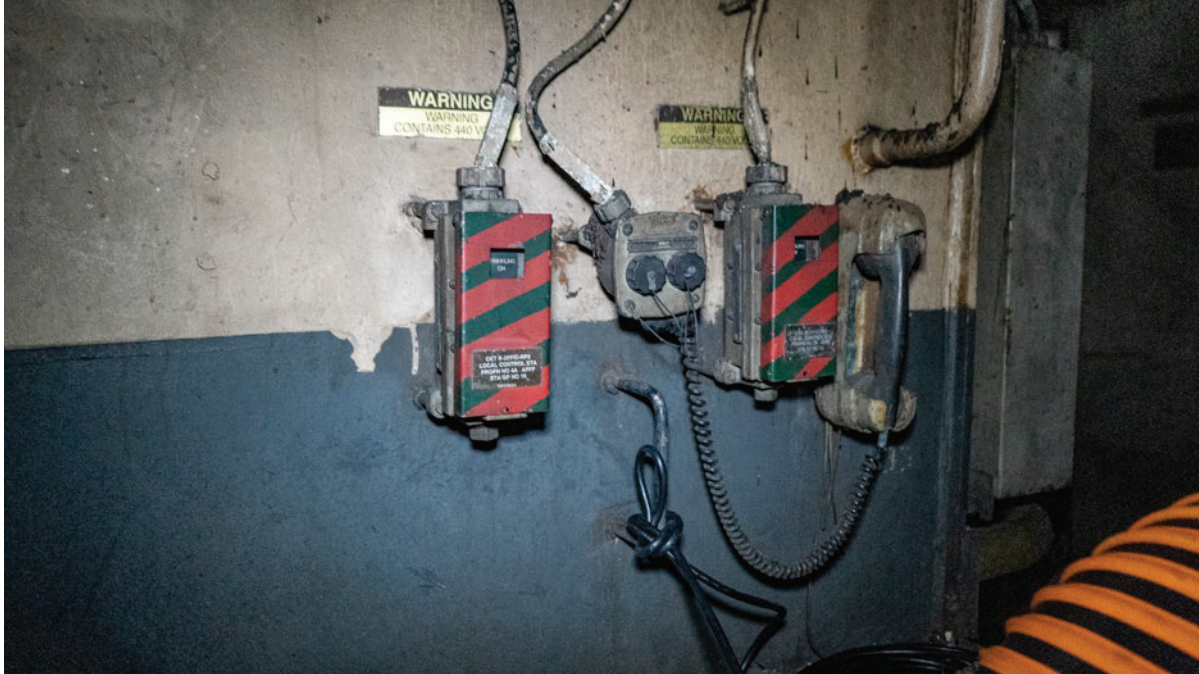
Figure 31, Still photo of AFFF push-buttons for sprinkler groups 15 and 16 serving Lower V with covers closed (16 on left; 15 on right). These push-buttons are in Upper V amidships.

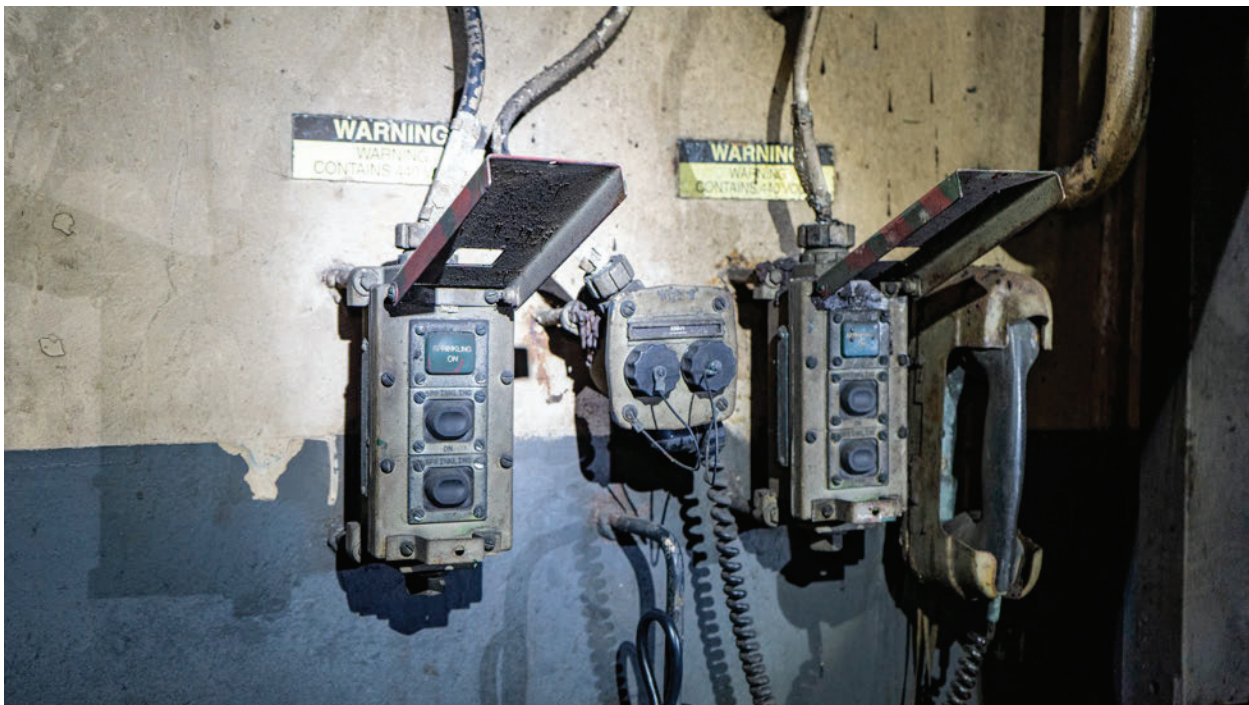
Figure 32, Still photo of AFFF push-buttons for sprinkler groups 15 and 16 serving Lower V with covers open (16 on left; 15 on right). These push-buttons are in Upper V amidships.

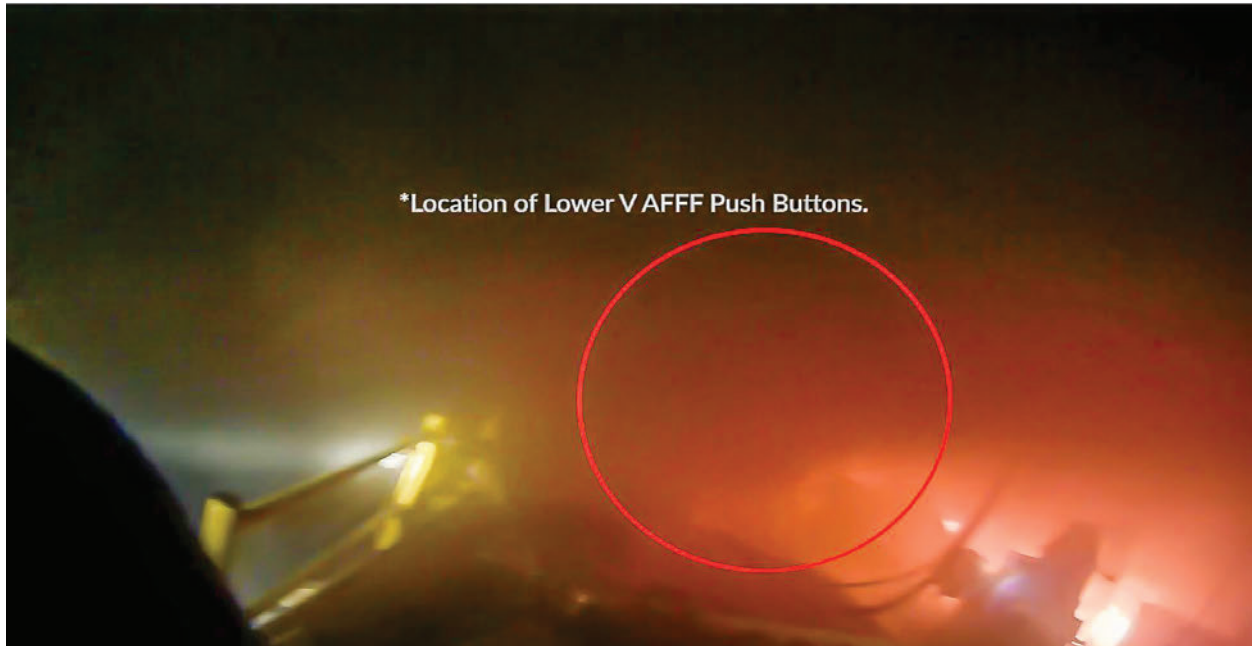
Figure 33, Still photo captured from GoPro video provided by San Diego Fire Department (SDFD) showing the location of AFFF push-buttons on 12 July 2020 after SDFD made entry into the vehicle stowage area via the sideport.

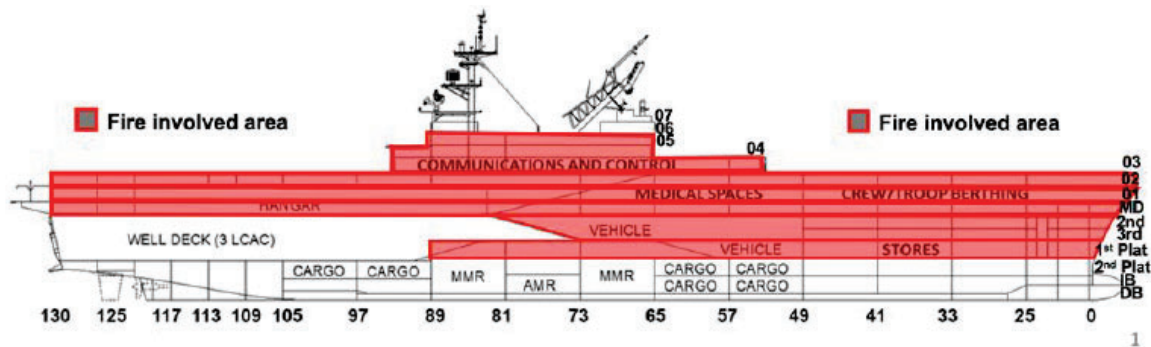
1040. To determine the full scope of damage to BONHOMME RICHARD, the MA initially divided the ship into zones, with the intent to assess each compartment within a respective zone for structural, fire/heat, or water damage. Due to the catastrophic nature of the actual damage conditions, the MA modified their initial compartment-by-compartment assessment to instead provide a gross assessment of groups of compartments. In many areas, the damage was so extensive that the MA was unable to identify specific compartments, as the fire and explosions created large open areas spanning several decks. Overall, the MA concluded that approximately 63 percent of BONHOMME RICHARD was impacted by the fire. [Encl 731, 994]

Figure 41 is a MA diagram indicating the fire-involved areas of BONHOMME RICHARD.

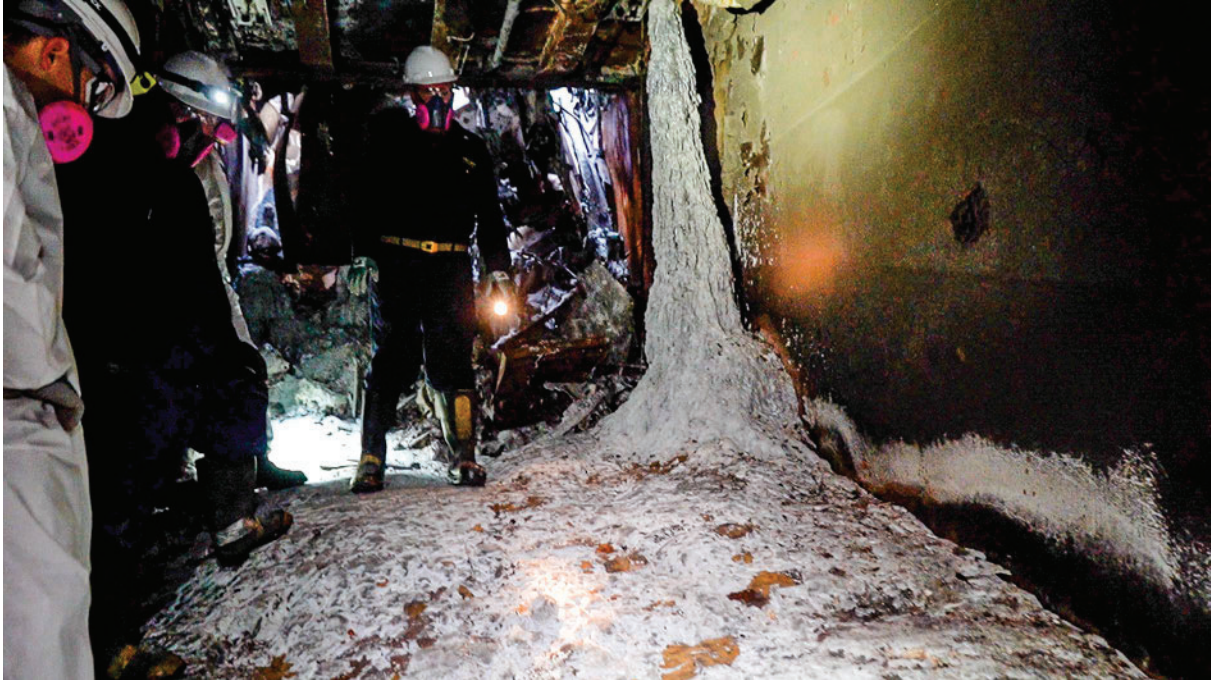
1041. The damage to the island is particularly notable, as the interior of the island is constructed primarily of aluminum, which has a lower melting point than carbon steel. The island was completely hollowed-out by the fire, transforming nearly a third of the 300-ton structural mass into molten aluminum. This molten aluminum drained through the island’s Flight-Deck level foundation penetrations onto the decks below, creating lava-like flow across lower-level steel decks and through vertical deck penetrations. No material remaining within the island is salvageable, as the fire essentially left exterior bulkheads with no other support structure. Due to the lack of structural integrity, should the ship be towed on the open-ocean, the island must either be removed or buttressed. [Encl 731, 995, 996, 997, 998]

Figure 42 shows investigation team members examining a solidified aluminum flow.

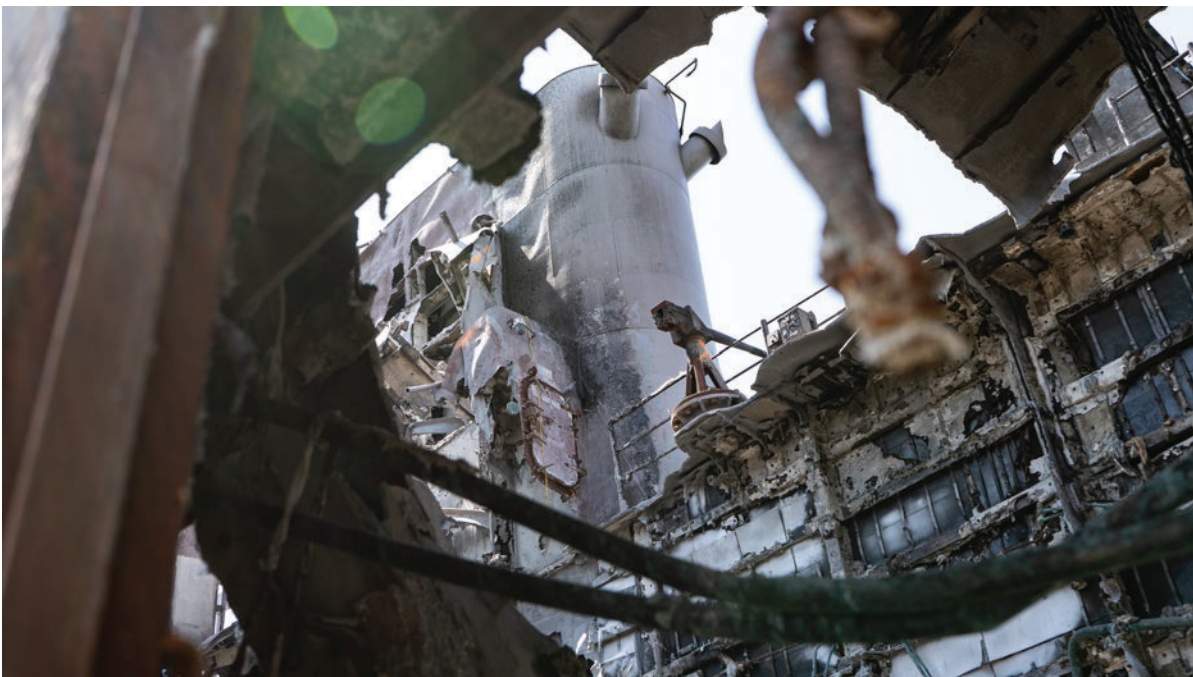
1042. As noted above, the loss of the interior island structure compromised the island's structural integrity, leading to the collapse of the forward mast and necessitating the removal of the aft mast in the weeks after the fire. [Encl 731, 999, 1000]

Figure 43 shows the island's interior, illustrating that the overhead has completely burned away.

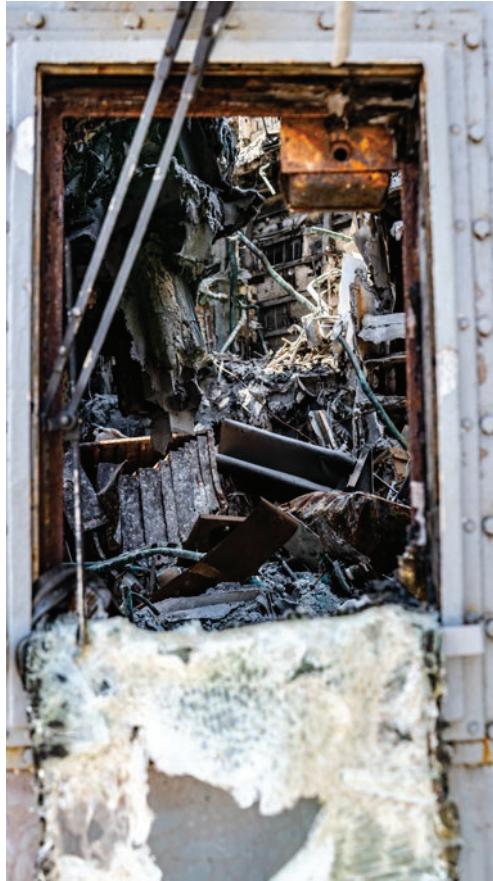
Figure 44 is another photograph of the island's interior.

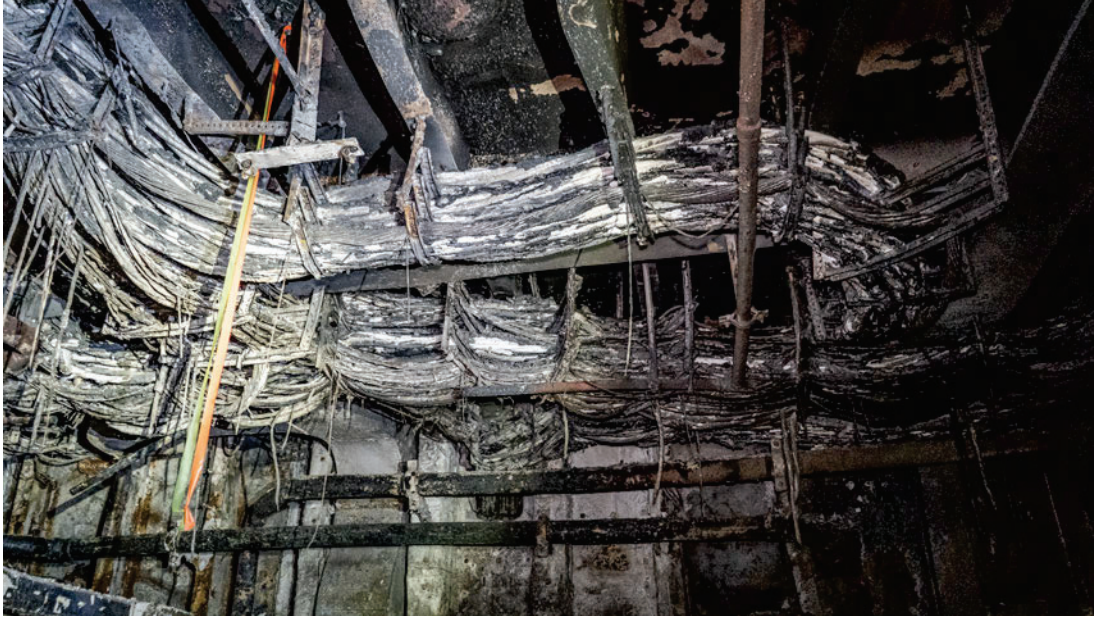
1045. The MA did not fully assess damage to distributed systems, such as ventilation, heating/cooling, potable water, chill water, Collection, Holding, Transfer (CHT), and others. However, each system passes through both damaged and undamaged compartments, which would necessitate careful mapping for damage. [Encl 731]

Figure 45 shows burned cableways in the Lower Vehicle Stowage Area (Lower V).

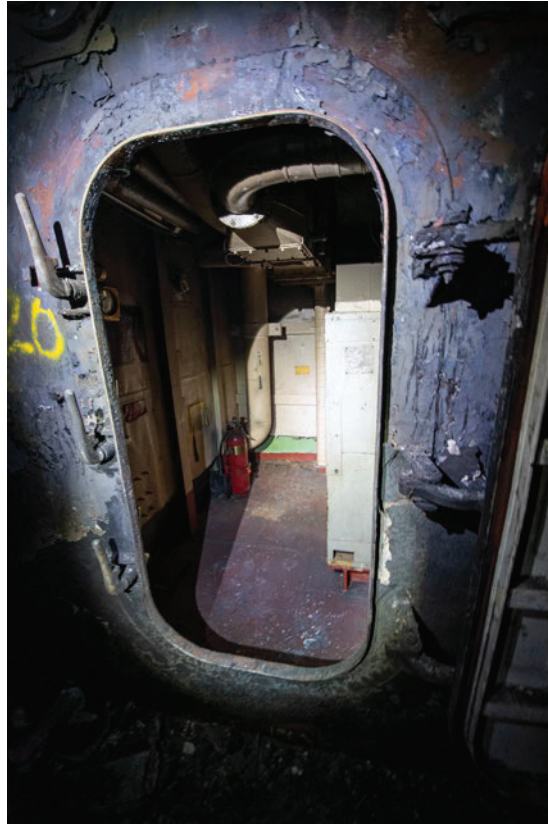
Figure 47 shows two compartments separated by a closed hatch. One compartment was severely damaged, while the adjacent compartment suffered minor damage.
